TEST REPORT

Sekisui Chemical GmbH
Königsallee 106
40215 Düsseldorf

FFU SLEEPERS BENDING TESTS AT LOW TEMPERATURE

Static centre load tests

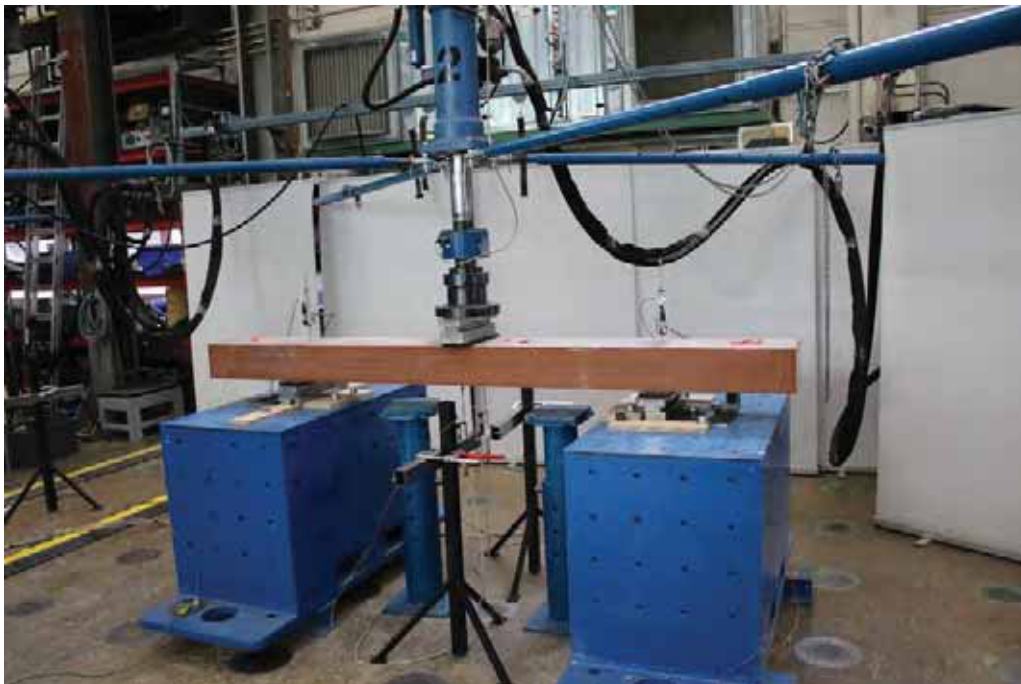
Figure 1 Test arrangement.

Tampere University tested Sekisui FFU sleepers at low temperatures that may occur in Finland. Initial temperature target was minimum -40 Celsius degrees, but the cooling arrangement led to even lower temperatures. All loading tests were load-controlled and performed according to European standard EN 13230-2, that describes load test for concrete sleepers. A static load was applied on center of sleeper. The distance between supports was 1600 mm and the supports were 100 mm wide. Between supports and sleeper were installed 15 mm thick resilient pads. Two vertical displacement transducers were installed directly above the support points, and two displacement transducers were installed directly below the loading point. The test arrangement is shown in Figure 1.

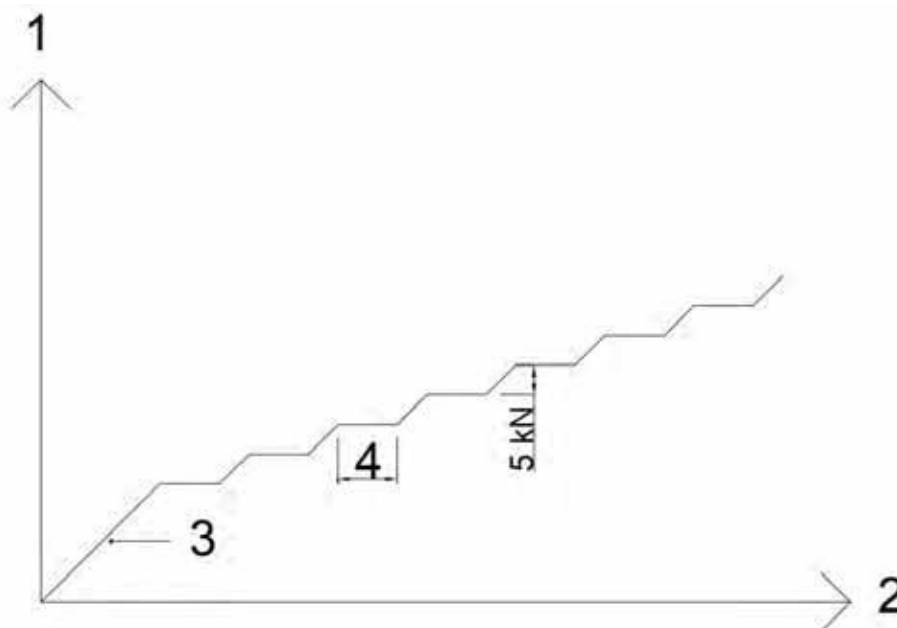
Figure 2 Principle of loading steps in the load tests. In figure: 1 = load, 2 = time, 3 = 50 kN/min and 4 = 15 s.

The initial load was set to 30 kN (first load step 0 to 30 kN). After initial load phase the load was increased in steps of 5 kN. Time between the load steps was 15 seconds. The load was increased at speed of 50 kN/min. The principle of the loading curve is shown in the Figure 2. The recording frequency of the measurement results was 1 Hz.

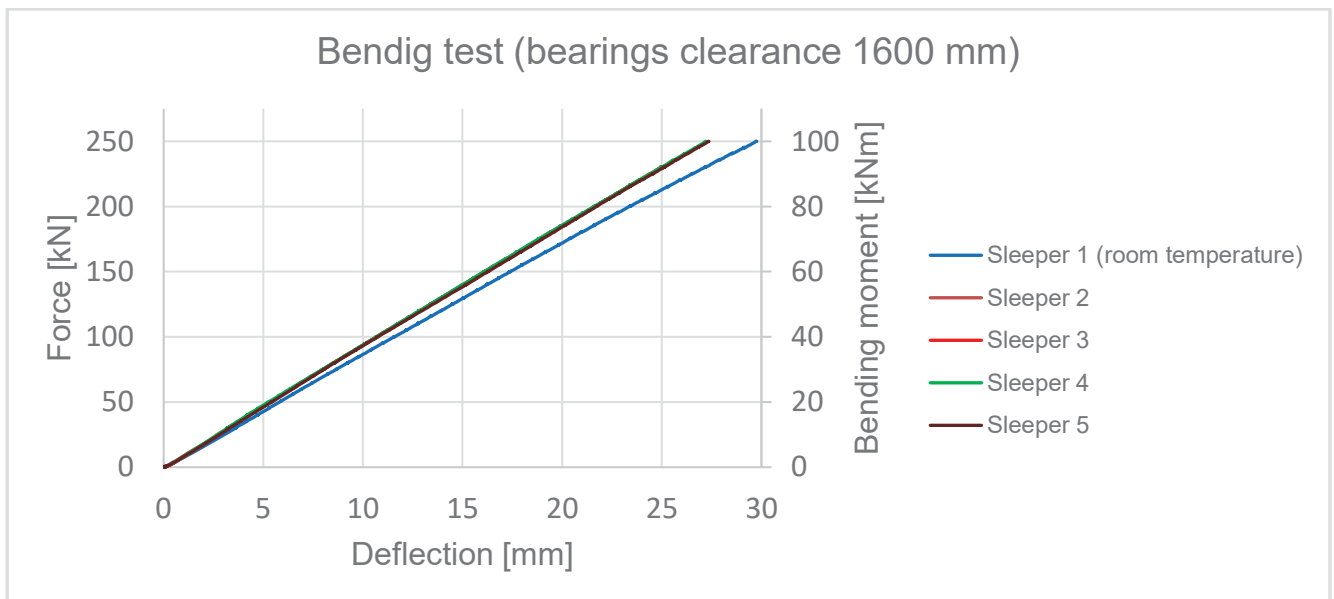
Figure 4 Force-deflection –diagrams of sleepers.

All force-deflection –diagrams of FFU sleepers are presented in figure 4. Bending test results showed a very high bending tensile strength. In two tests (sleeper 2 and sleeper 3) the maximum load was 230 kN and in three tests (sleeper 1, sleeper 4 and sleeper 5) 250 kN. The stiffness of the material increased slightly at low temperature. The variation between tests was negligible.

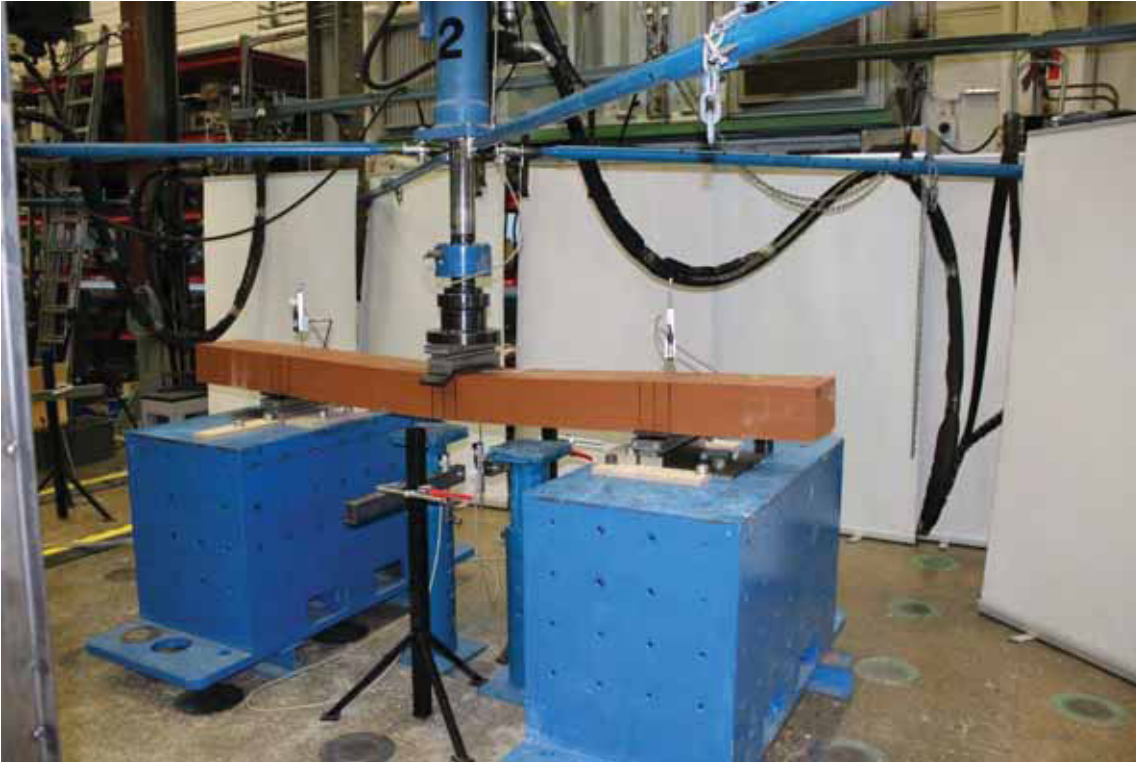
Sleeper 1, load 250 kN.

After the tests all the FFU sleepers were visually inspected. No cracks were detected within the bending tensile area or anywhere else on the surface of the sleeper.

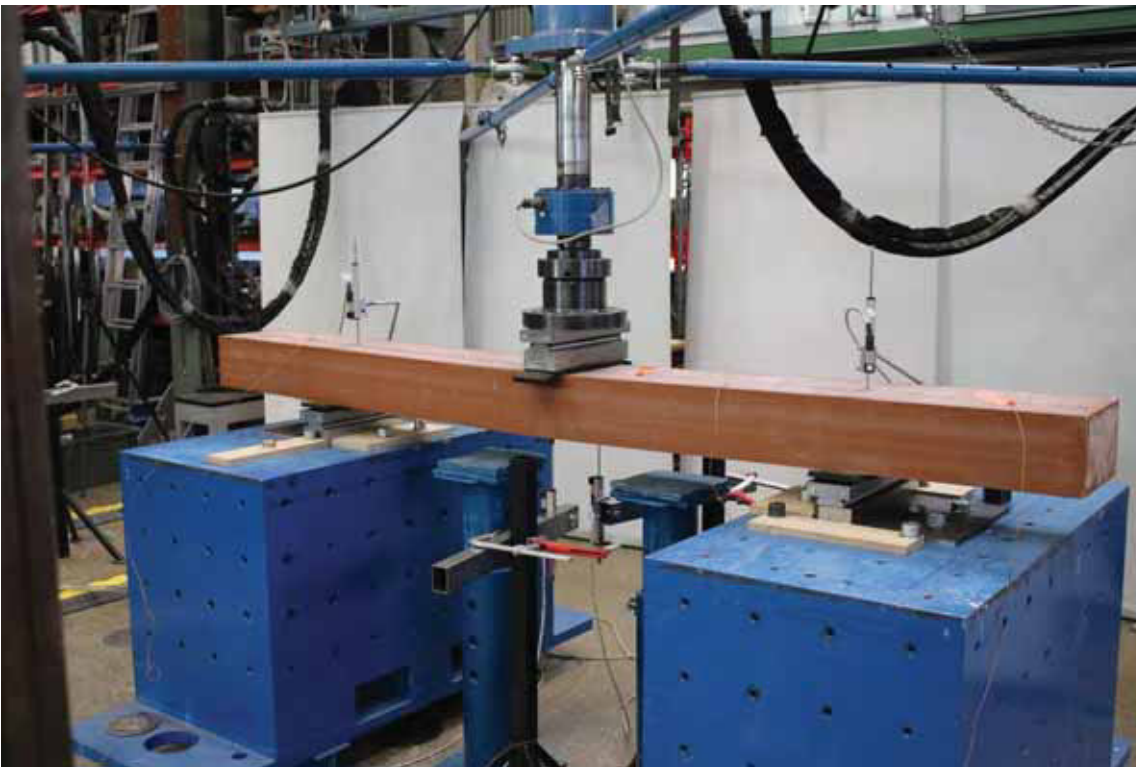
Sleeper 3, load 120 kN.

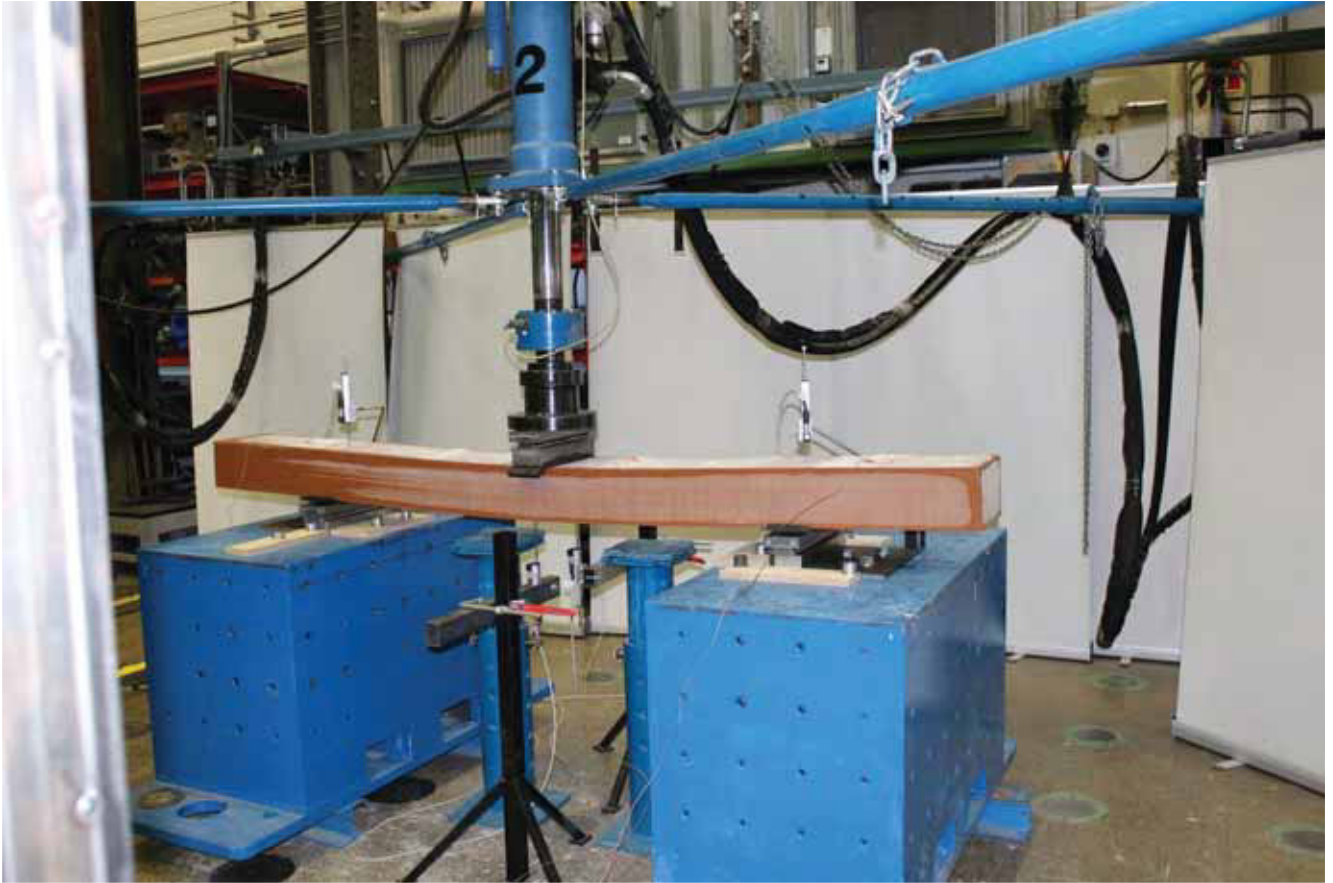
Sleeper 5, load 250 kN.
